Home Inspection Report

Report Number: 4-27-144

144 Fairfield Circle
Raeford , North Carolina 28376

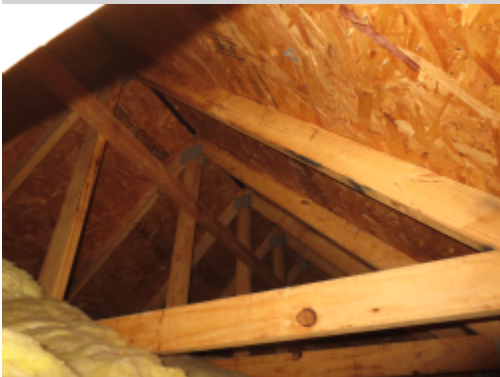
(A6 - 1.1) All Accessible Areas

Additional Photograph: This is a photograph of engineered trusses and roof sheathing

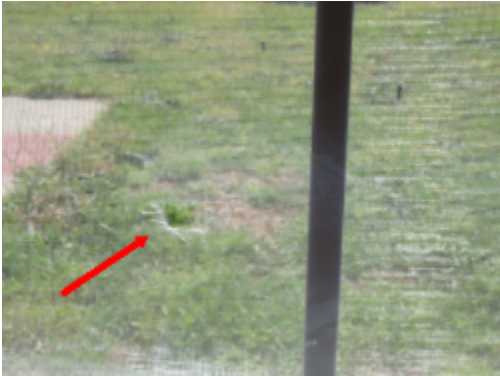
(B2 - 1.1) All Windows

The window screens in the dining room have holes in them and may allow bugs to enter the house when the windows are open A general contractor should be contacted to evaluate the condition to decide weather they can be repaired or should be replaced

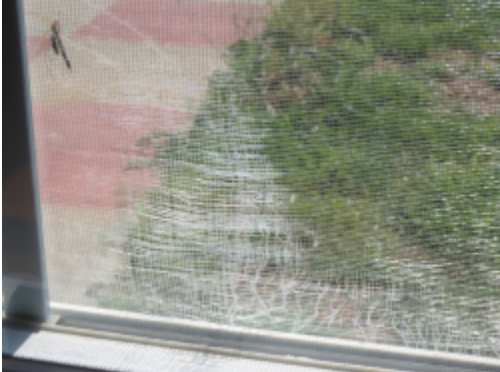
(B2 - 1.2) All Windows

Additional Photograph: This a photograph of the second screen in the dining room

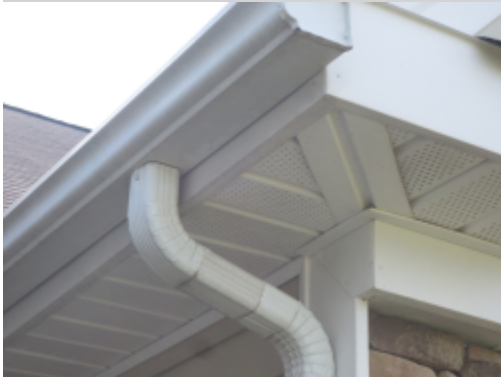
(C2 - 1.1) Main House

Additional Photograph: This is a photograph of the gutter and down spout over the front door area

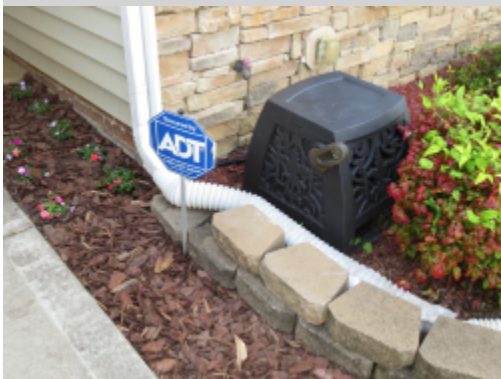
(C2 - 1.2) Main House

Additional Photograph: This is a photograph of the down spout extension carrying the water away from the foundation

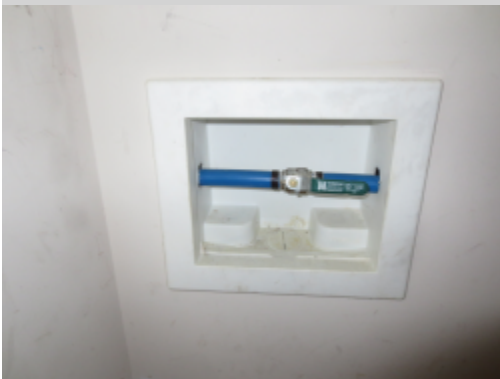
(D1 - 1.1) All Accessible Areas

Additional Photograph: This is a photograph of the main water shut off in the front hall closet

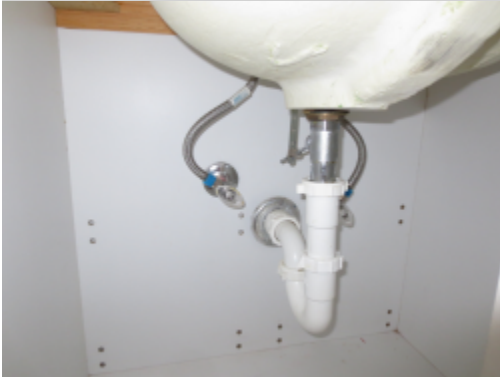
(D2 - 1.1) All Accessible Areas

Additional Photograph: This is a photograph of the P trap under the upstairs bathroom sink.

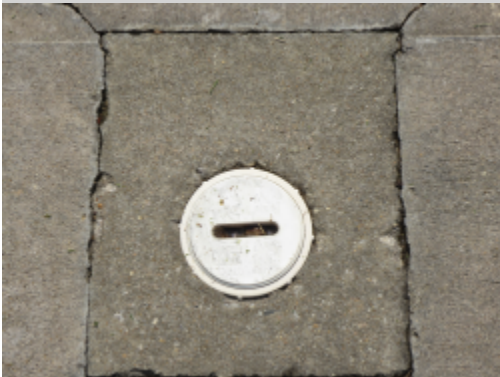
(D2 - 1.2) All Accessible Areas

Additional Photograph: This is a photograph of the main waste line clean out in the driveway

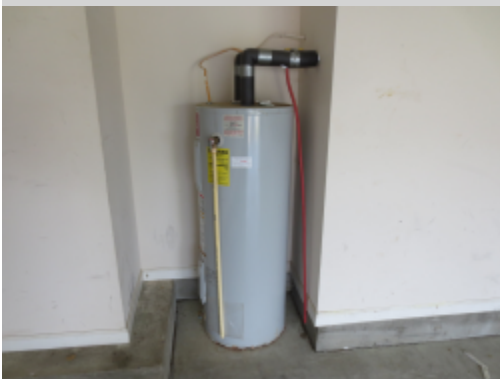
(D3 - 1.1) Unit #1

Additional Photograph: This is a photograph of the water heater located in the garage

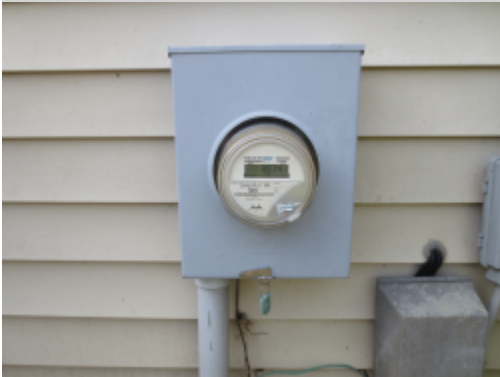
(E1 - 1.1) Type: Underground

Additional Photograph: This is a photograph of the main service meter located on the left side of the house

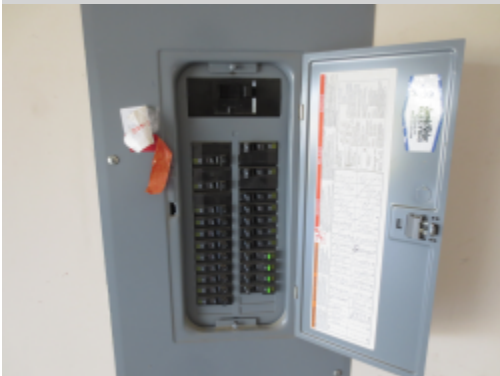
(E2 - 1.1) Main Panel #1

Additional Photograph: This is a photograph of the main electrical panel located in the garage

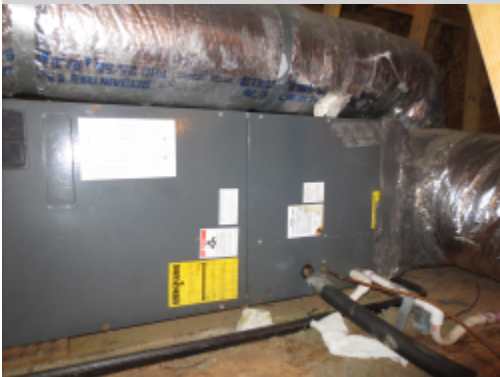
(F1 - 1.1) Heating Unit #1

Although the secondary drain is present there is no electric pump present to remove water from the drain pan in the event that the primary drain becomes plugged. This may cause condensate water to overflow damaging the finished drywall space below and over time could cause rot damage to the wood structure supporting the unit. A HVAC contractor should be consulted for a complete evaluation and to make necessary repairs to ensure safe, reliable, and proper operation of the HVAC system.

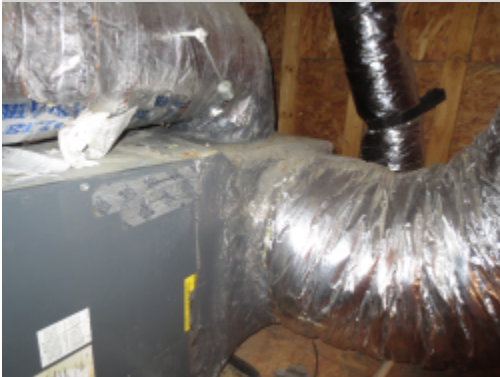
(F2 - 1.3) Heating Unit Served: Heating Unit #1

Additional Photograph: This is a photograph of the flexible branch duct work

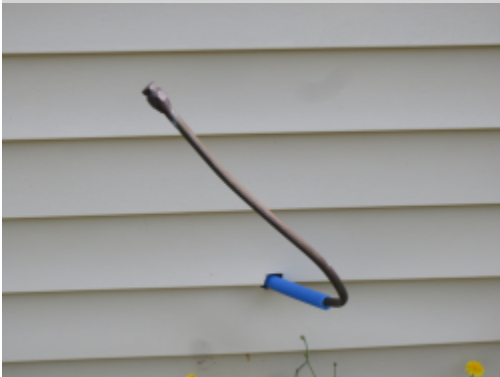
(F3 - 1.1) Fireplace Area

Additional Photograph: This is a photograph of the gas line running to the fire place however there is no fuel tank present

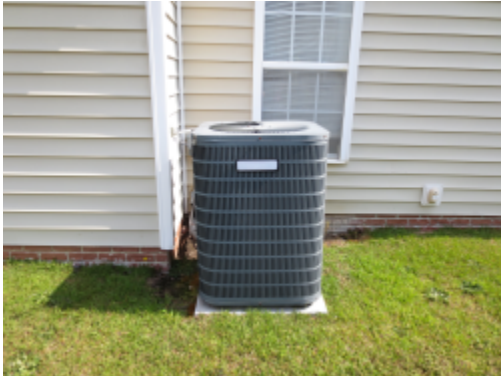
(G1 - 1.1) Cooling Unit #1

Additional Photograph: This is a photograph of the outside unit located on the right side of the house

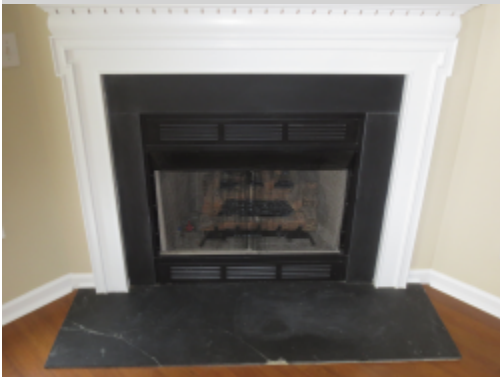
(H6 - 1.1) Fireplace: Pre-Manufactured: Metal: Box: Sided Exterior

The gas log unit located in the living room was visually inspected but not operated because the pilot was off and there is no propane tank present. The unit should be serviced and operated prior to closing to ensure safe and proper operation of the HVAC system.

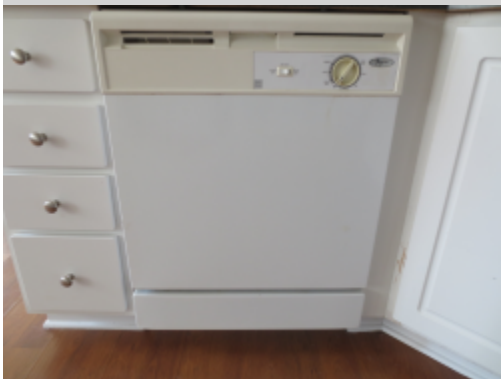
(J1 - 1.1) Dishwasher

Additional Photograph: This is a photograph of the dish washer

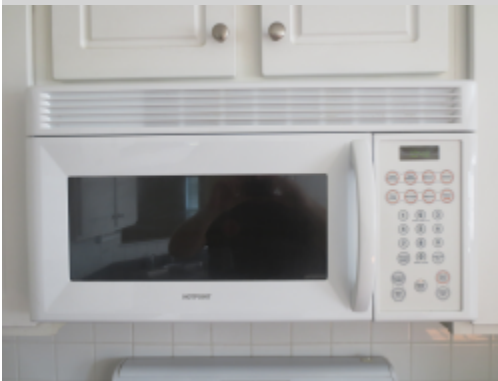
(J1 - 3.1) Microwave: Over Range

Additional Photograph: This is a photograph of the microwave over the range

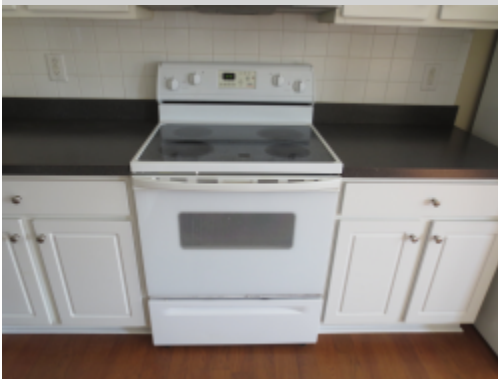
(J1 - 4.1) Oven: Electric

Additional Photograph: This is a photograph of the electric oven/range
