Property Inspection Report

Report Number: 99-99-9999

194 Weldon Dr
Pinehurst, North Carolina 28384

Date of Inspection: Monday, December 1, 2025

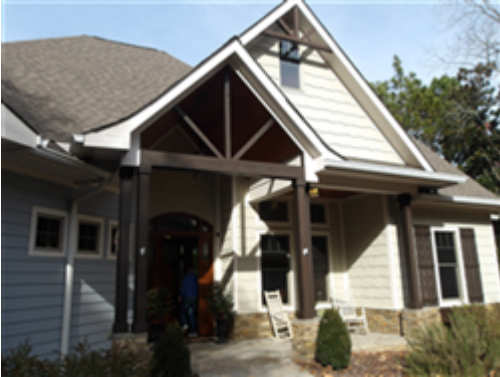
(A2 - 1.1) Porch: Front

Photo showing exterior columns located on front porch. This is for your information only.

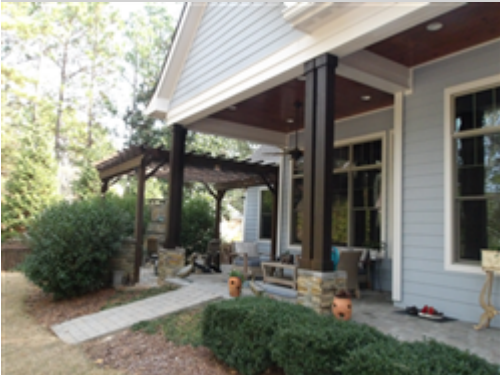
(A2 - 2.1) Porch: Rear

Photo showing exterior columns located on rear porch. This is for your information only.

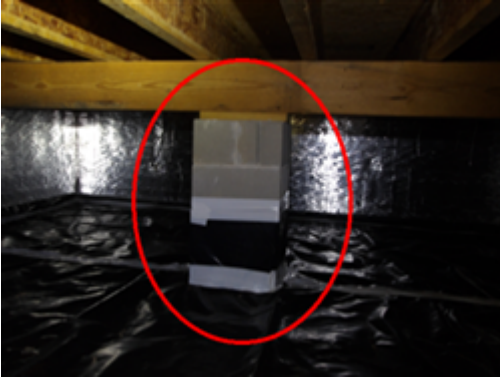
(A2 - 3.1) Main House

Photo of a pier located in the crawlspace area. This is for your information only.

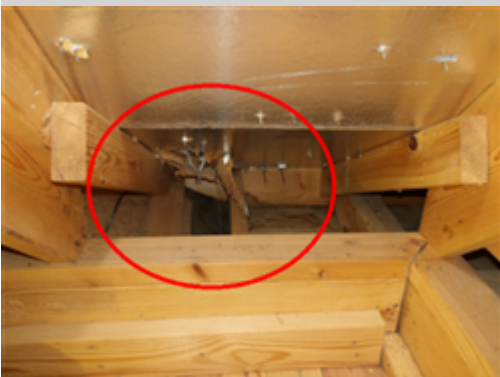
(A6 - 1.1) Main House

From the attic, the roof decking had areas that were discolored and damaged. At the time of inspection, it could not be confirmed if the stains were from a current or previous roof leak. Recommend owner disclosure of the area, if the home owner is unaware, a licensed roofing contractor should be consulted to evaluate and make any necessary repairs to ensure the weather tightness of the area.

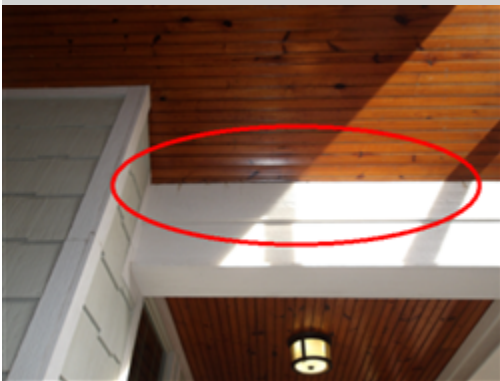
(B1 - 1.1) Main House Front: Porch

Round holes typical of boring/carpenter bees were noted in the soffit over the front porch. Boring Bees damage wood by boring deep tunnels. Repairs are needed and the bees need to be controlled. A pest control specialist should be consulted. A licensed general contractor should be consulted for a complete evaluation of the exterior of the home to determine the extent of the damage to the siding, boxing, trim, and underlying components to prevent further damage.

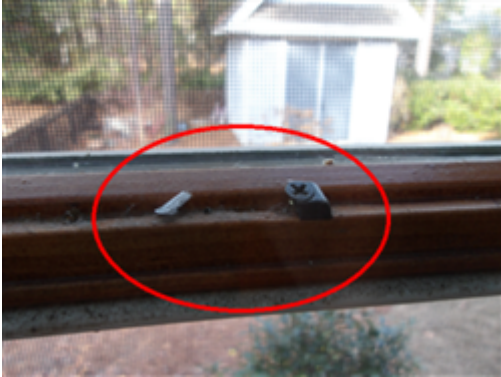
(B2 - 1.1) Windows

One of the window locks was noted to be damaged on one of the master bedroom windows. Recommend a qualified person or licensed repair specialist to evaluate and repair as needed.

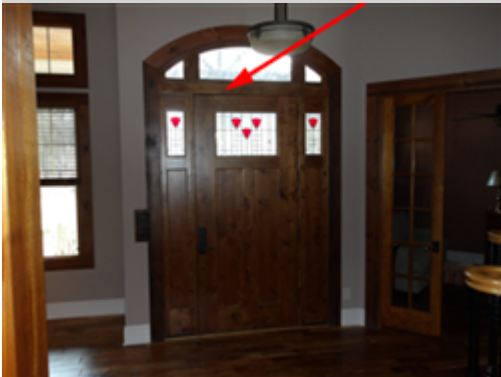
(B2 - 2.1) Door

The front door weather-stripping is damaged along the top. The weather-stripping needs repair/replacement to ensure that the door closes securely and is weather tight. A general repair specialist or licensed general contractor should be consulted for evaluation and repair.

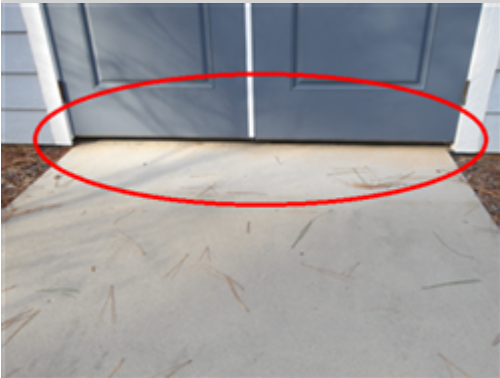
(B2 - 7.1) Doors

A large gap exist under the bottom of the doors on the detached building. This opening can allow for insect and wildlife intrusion that can result in undesirable conditions. Recommend consulting a licensed general contractor to evaluate this concern and make repairs as needed.

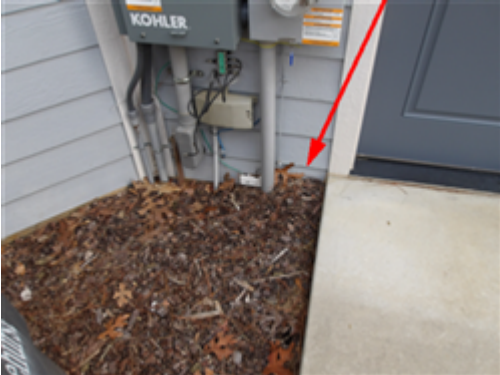
(B5 - 1.1) Grading

The grading around the left rear foundation of the home is too high in some areas and does not allow proper clearance between the soil/bedding materials and the wall cladding. Incorrect clearance can result in water penetration, poor drainage, conditions conducive of insects and decay, and limited inspection areas. A licensed general contractor should be consulted to evaluate and correct the grading as needed for proper clearance and drainage. As repairs are made, siding and the adjacent hidden framing areas should be checked for hidden damages and made repairs as needed.

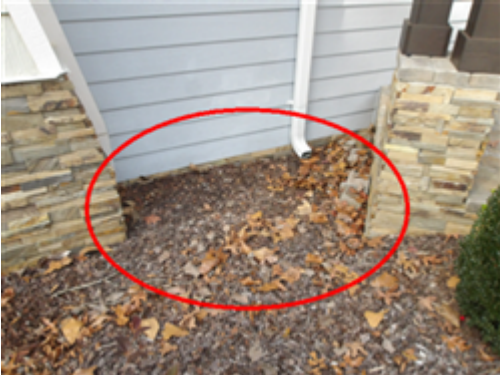
(B5 - 1.2) Grading

The front left downspout empties into an area to the left of the main entrance that does not allow for the water to drain away from the foundation. This can result in damages to the foundation. Recommend a licensed general contractor to evaluate this concern and make repairs as needed.

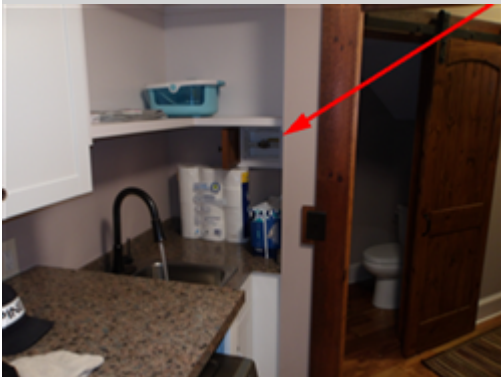
(D1 - 1.1) All Accessible Areas

Photo showing emergency water shut off valve located in the laundry room. This is for your information only.

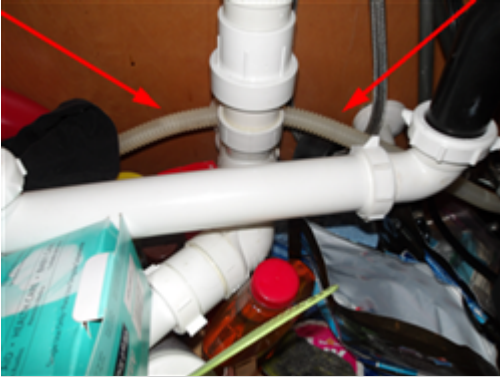
(D2 - 1.1) All Accessible Areas

The drainage pipe from the dishwasher to the sink plumbing was not installed in manner to prevent sewer from backing up into the unit in the event of a plumbing clog. The dishwasher needs further evaluation and repair to ensure sanitary conditions and proper operation. An appliance repair specialist should be consulted.

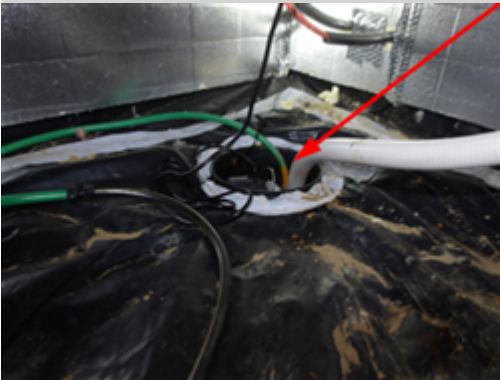
(D2 - 1.2) All Accessible Areas

Photo of sump pump in crawlspace. This is for your information only.

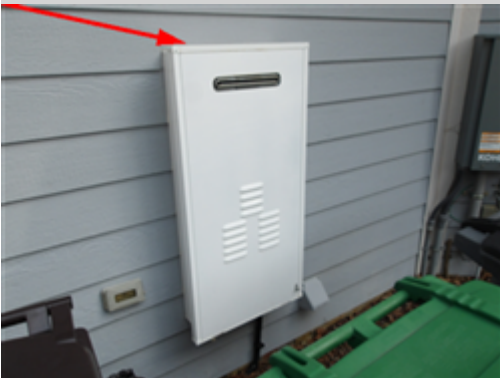
(D3 - 1.1) Unit #1

Photo showing tankless water heating unit located on exterior of the home. This is for your information only.

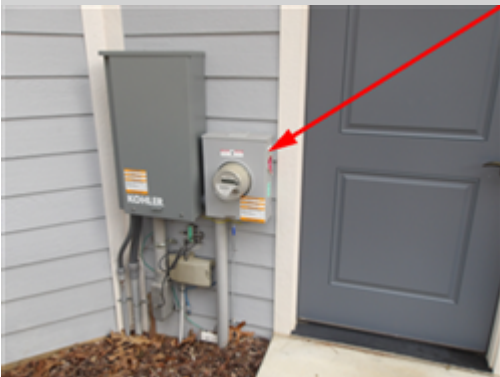
(E1 - 1.1) Underground

Photo of main electrical service. This is for your information only.

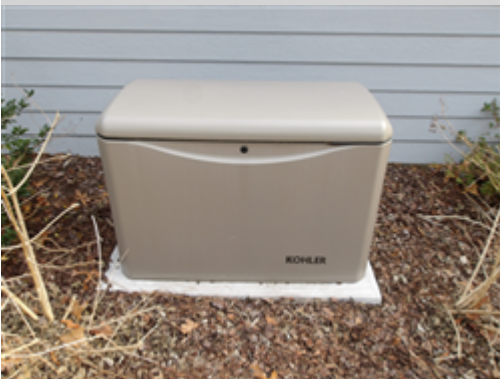
(E1 - 1.2) Underground

This home is equipped with a generator. The inspection/operation of the generator is beyond the scope of the home inspection. The operation of the generator requires specific instructions. A licensed electrical contractor should be consulted to operate and evaluate the system to ensure proper/safe performance and to inform the buyer of safe operational procedures.

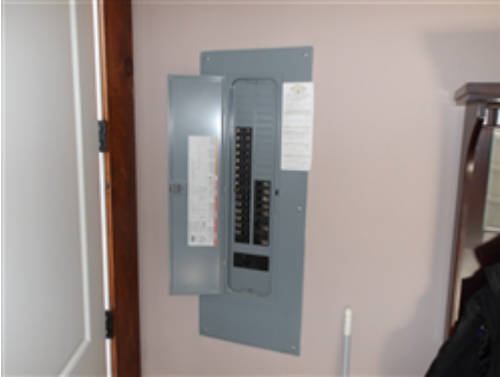
(E2 - 1.1) Main Panel

Photo of main electrical panel located in the garage area. This is for your information only.

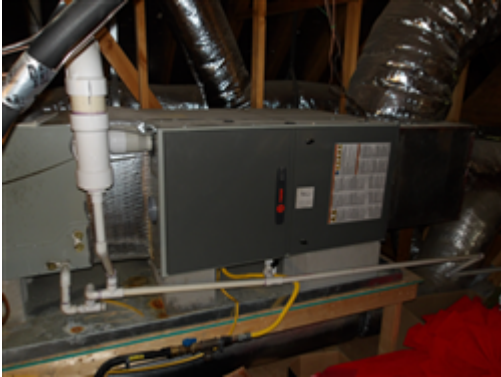
(F1 - 1.1) Heating Unit

Photo of furnace in attic area. This is for your information only.

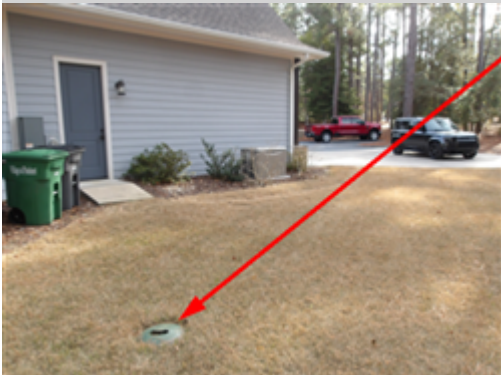
(F3 - 1.1) Crawl Space

The home has an under ground fuel storage tank; storage tanks are either leased from the fuel supplier or owned by the homeowner. The buyer should request more information concerning the storage tank, service requirements and ownership.

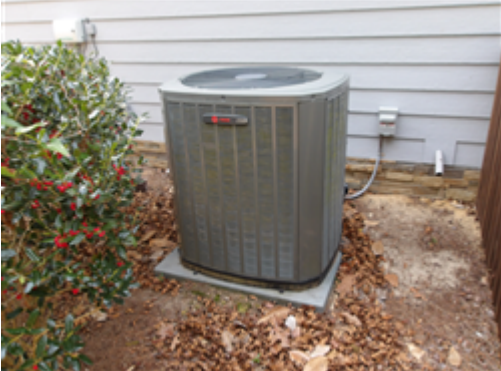
(G1 - 1.1) Cooling Unit

Photo of exterior HVAC unit. This is for your information only.

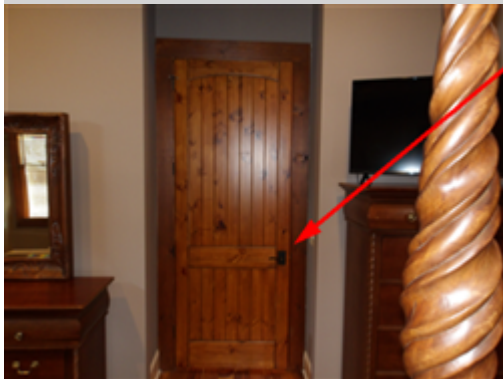
(H1 - 1.1) All Rooms

The master bedroom and master bedroom closet door knob assemblies are not aligned with the striker plate in the jamb area. The strikers could not engage properly to secure the doors. The door/jam needs repair to ensure that the doors close securely and operate properly. A general repair specialist should be consulted for evaluation and repair.

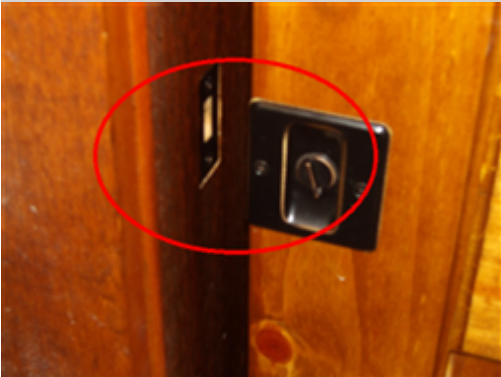
(H3 - 2.1) Bathroom: Jack and Jill

The pocket door locking mechanism is not aligned with the striker plate in the jamb area. The striker could not engage properly to secure the door. The door/jam needs repair to ensure that the door closes securely and operates properly. A general repair specialist should be consulted for evaluation and repair.

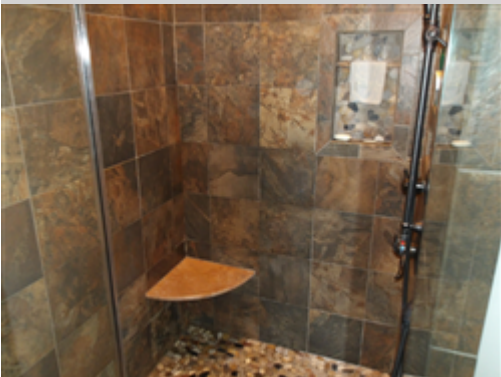
(H3 - 3.1) Bathroom: Master

The grouting for the tile system in the master bathroom shower needs further evaluation and repairs. Color change to the grout was noted when it became wet indicating water intrusion due to the grout not being sealed. Damages will occur to the grout and areas behind the tiles if the grout is not sealed. Recommend builder notification to ensure further evaluation of all tile surfaces and repairs are completed by a qualified contractor.

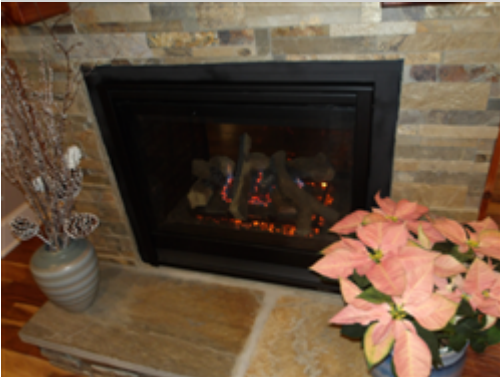
(H6 - 1.1) Fireplace: Pre-Manufactured: Metal: Box: Masonry Exterior

Photo of gas logs in operation. This is for your information only.

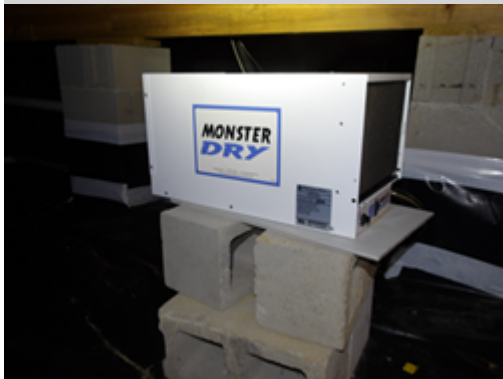
(I1 - 2.1) Crawl Space

Photo of dehumidifier located in the crawlspace area. Recommend home owner disclosure for operation and maintenance requirements. If owner is unaware, it is recommended to consult with an HVAC contractor.

Photo of dehumidifier located in the crawlspace area. Recommend home owner disclosure for operation and maintenance requirements. If owner if unaware, it is recommend to consult with an HVAC contractor.
